The Corrosion of Water Plants

C. Paglia and C. Mosca

Abstract

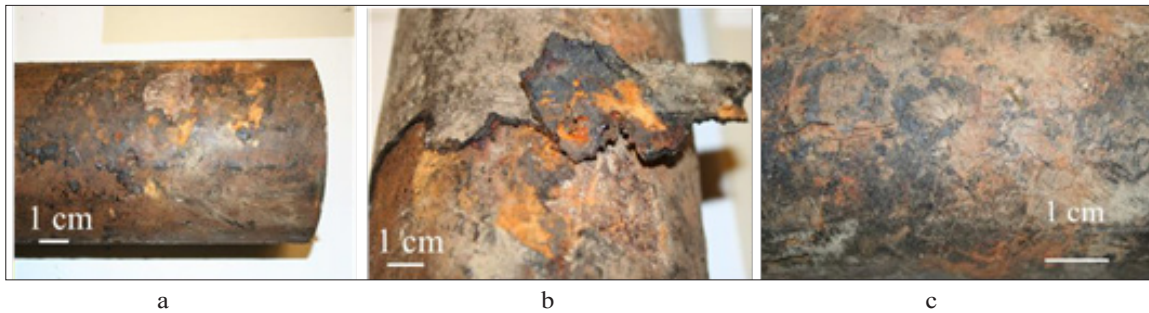
The pipelines were coated with a bituminous-based system with an original thickness ranging from 2 to 3 mm. At the time of the investigation, the coating thickness was reduced to 1-3 mm (Fig. 1a). Local cracks were present and reached the steel surface causing the coating detachment (Fig. 1b). The crack pattern assumed a net-like shape (Fig. 1c). A slight surface uniform corrosion was observed, although locally also some craters were detected.

Figure 1: External coating degradation of the pipe.

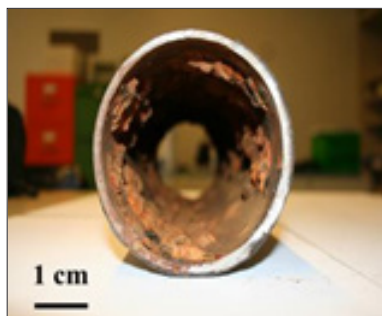
a

The internal pipe coating thickness was 0.5 mm. In some areas, the coating detached or was absent. In these zones, corrosion initiation was observed (Fig. 2 a). Locally the degradation was intense. Nevertheless, the electrochemical attacks never led to perforation of the pipe wall (Fig. 2b).

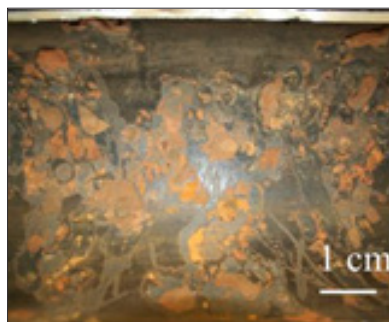
b

During 40 years, a constant degradation occurred on both the external and internal coating system. In spite of the local intense damage, the corrosion was mainly seen as an uniform attack that proceeded at a slow speed with time and did not lead to perforation.

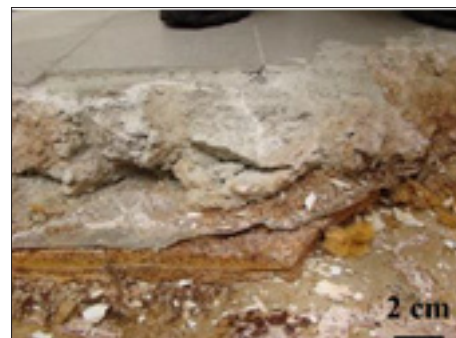
A water heating pipeline plant was placed within a pavement. The upper surface level consisted of tiles with 1.2cm in thickness, fibre reinforced cement-based material and a rebar net for a total thickness of 10cm. Underneath a plastic foil, a styrofoam insulation with a thickness of 2cm and a 2cm thick mineral wool insulation were placed. The base of the pavement consisted of concrete (Fig. 3a). Corrosion was seen along a Zinc-coated steel curvature. Sometimes the deterioration exhibited an initial stage (Fig. 3b). In other regions, the corrosion indicated an advanced stage with localized corrosion, the formation of craters on the external surface, current exit, perforation and water leakage (Fig. 3c).

Figure 3: Pavement stratigraphy (a) and pipe external corrosion (b, c).

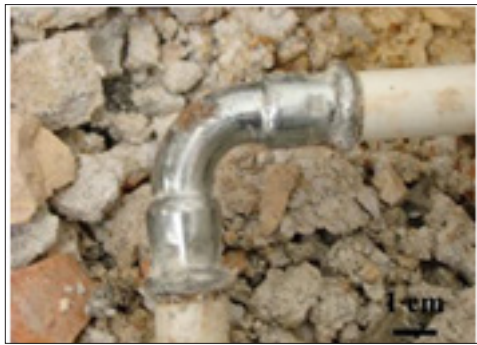
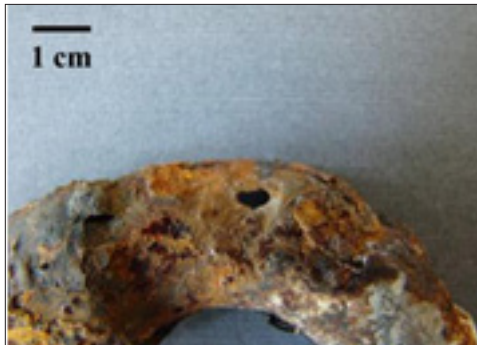
In this case, the corrosion took place mainly along the external part of the pipeline. This was due to the relative presence of humidity / water enrichments and the lack of an appropriate embedment or protection of the metallic parts. This occurred during the placing works or with time due the inappropriate quality of the materials and coatings.

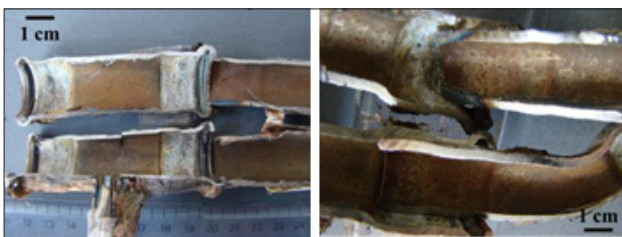
The internal surface exhibited a slight corrosion of the pipe and the junctions (Fig. 4a). The chemical analysis of the water indicated only a slightly aggressive environment, that was caused by the free-CO₂ content (Fig. 4b).

Figure 4: Internal pipe and junction corrosion.

A chemical analysis of the Zinc-coated curvature showed a reduction of the Zinc content caused from corrosion. A variation of Silicon, Manganese, Chrome and Titanium was seen between the corroded and the uncorroded portions (Table 1). The chemical variation influenced the stability of the Zinc coating. In addition, the presence of inhomogeneities also influenced the corrosion. Furthermore, the bending process of the curvature may form microcracks and acts as initiation points for degradation. The lack of a synthetic coating may further reduce the corrosion resistance in such an environment.

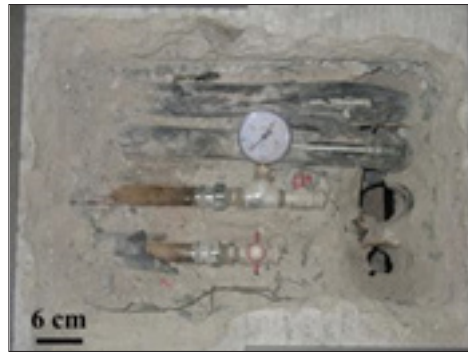
In a water cooling / heating plant a Zinc coated pipe for warm water was placed on the upper level of a pavement, while the cold water pipe system was present at the lower level. Both systems were relatively close one another (Fig. 5a). The water cooling plant exhibited external corrosion with a crater formation and perforation (Fig. 5b). The system exhibited a slight corrosion of the internal pipes only after one year of service (Fig. 5c). The water chemical analysis showed a poorly aggressive water with no presence of CO₂ aggressive (0.0 mg/L) and a relatively low chloride content (10.6 mg/L). The embedding cementitious material around the insulating pipe exhibited conventional chloride, sulphate, nitrates and calcium content. They could not be considered critical with

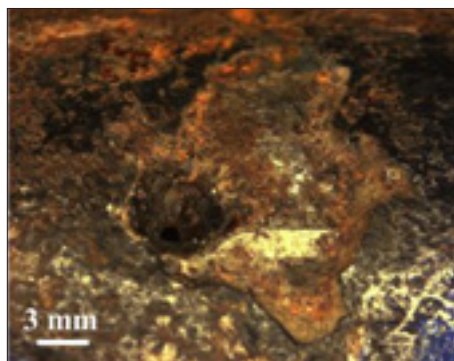
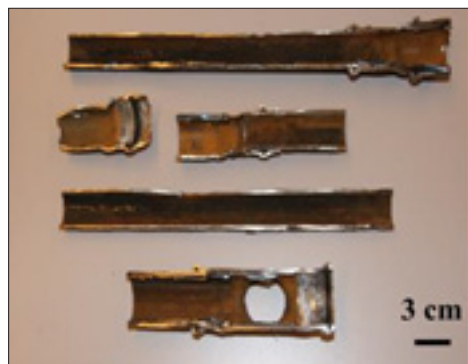
respect to localized corrosion. The corrosion occurred in the cooling pipes and was caused by the lower surface temperature of the pipe (7-12 °C). The heating pipe plant did not show damage. The external corrosion with the formation of crater was due to the presence of humidity, local chemical impurities and an inappropriate Zinc coating. The thermal insulation layer avoided the direct contact of the pipes with the basicity of the cementitious material, thus reducing the protection. Furthermore, the insulation embedment acted as a sponge for the humidity and enhanced the corrosion processes.

Figure 5: Water cooling/heating systems and corrosion features

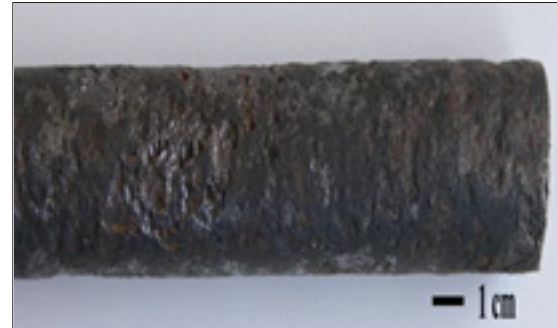
A further cooling / heating plant consisted of a low alloyed carbon steel, type 1.0034 E 195, with a thin wall welded longitudinally. The Zinc coating thickness was 8-12 μm . The plant transported warm water in the Winter time and cold water in the Sommer. Within the room, steady-state humidity conditions dominated and no increases were detected. Intense uniform corrosion with local crater formation and perforation

were seen (Fig. 6 a). A presence of humidity with water condensate were observed on the pipe external surface. A crater and a perforation of 1 mm diameter was seen from the external (Fig. 6 b) to the internal surface (Fig. 6 c). The internal pipe degradation was limited. Craters formed from the external surface. Internally, the presence of multiple pit-like degradation was detected (Fig. 6 c).

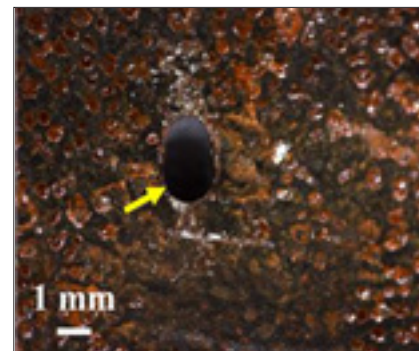
c

Figure 6: Advanced uniform corrosion with craters formation.

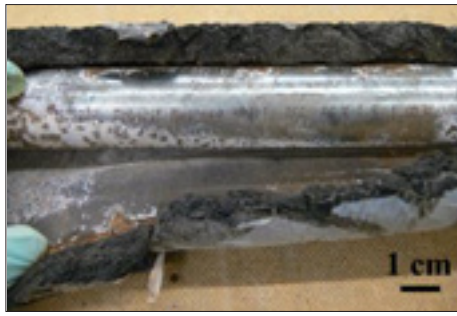
a

The corrosion of the Zinc coating, so called white rust, was promoted by the presence of humidity, and an initial corrosion of the underlying steel was seen (Fig. 7 a). In some areas the deterioration proceeded to an advanced level till perforation (Fig. 7 b).

Figure 7: White rust on the Zing coating and initial steel corrosion.

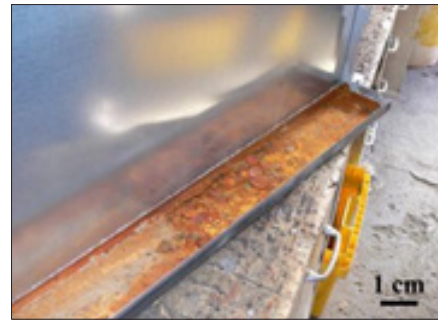
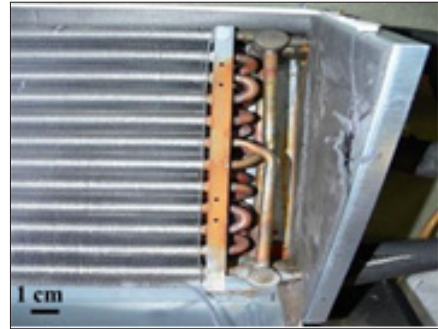
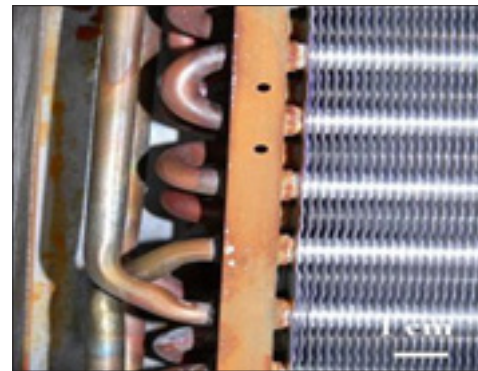
The air conditioners are widely widespread in order to maintain a healthy and an appropriate clima within rooms. The thermal and humidity sollicitations of such plants are high. The analyzed fan coils exhibited uniform corrosion along the internal surface of the collecting condensation water tank after a relatively short period of time of 2 years (Fig. 8 a). Along the lower surface of the collecting tray, white rust corrosion was seen. Uniform corrosion at an initial stage was present along the Zinc coated profiles in the zone of Cu-pipes insertion in the heat exchanger. On the other hand, no corrosion was found on the aluminum lamellae (Fig. 8 b). The measured Zinc coating thickness mean was $12.7 \pm 2.6 \mu\text{m}$ (out of 25 measurements). The tolerance range Z140 was 7-15 μm with a typical value of 10 μm or for Z200 with a range 10-20 μm with a typical value 14 μm [9].

Figure 8: Corrosion on a fan coil device.

The prolonged stagnant water, the too low Zinc coating thickness for such service conditions and the galvanic corrosion between the Copper tube and the Zinc coated elements (Fig. 8 c) promoted the degradation of the plant.

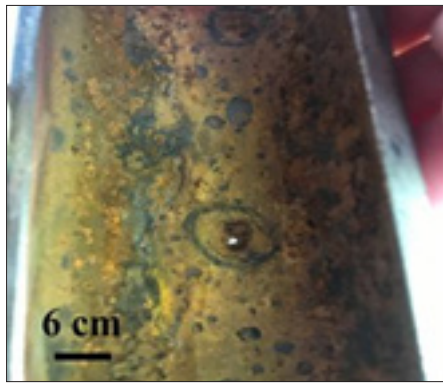
The sprinkler systems are among the first plants activated in case of fire. In a large shopping center a sprinkler installation was made of low alloyed steel 1.0034. Periodically, enlargements of the surface and the addition of new shops took place. The pipe system was alternatively emptied and filled with water to allow the construction works. In this manner, a periodical Oxygen enrichment could enter the pipe system. After a relatively short period of time, internal pipe corrosion appeared. The corrosion proceeded to an advanced stage. Craters formed from the inside till perforation (Fig. 9). Moreover, the sprinkler nozzles were oriented downwards. They were filled with corrosion products resulting from the pipe. Consequently, clogging of the system in case of fire could be expected.

Figure 9: Internal corrosion with craters of a sprinkler pipe.
