## Auscultation Techniques of Constituent Materials of Monuments and Ancient Constructions: Immediate Techniques and Instrumental Techniques

### Abstract

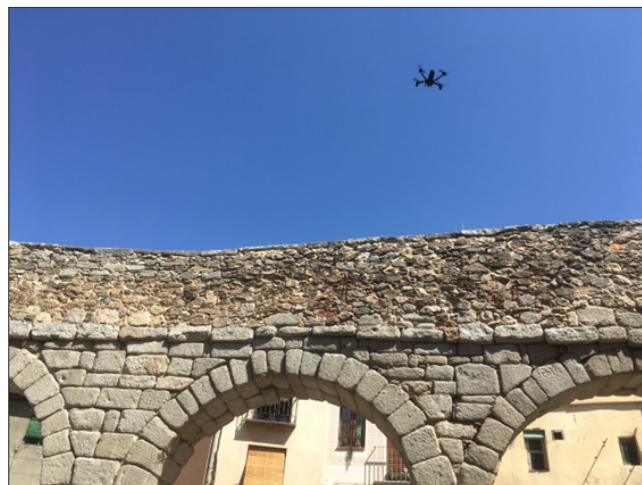
**Figure 1:** Quadrotor drone flying over the Roman Aqueduct of Segovia, for inspection (photo by the author).

In recent years, drones have been incorporated to carry out this type of inspection (Elizalde, 2022). Several experimental inspections carried out on constructions have shown that the use of a suitable drone (Fig. 1, Fig. 2 y Fig. 3) allows a detailed and complete visual observation (Fig. 4) of all the visible elements of the monument, accessible and non-accessible (Elizalde, 2022). The concept of accessibility is important because it is where the drone becomes most important: conceptually, the inspection must include all visible elements, whether they are accessible or inaccessible. Therefore, the maximum difficulty comes when an inaccessible element is visible: the drone usually reaches this point without any problem. Indeed, the drone does not meet the definition of immediate techniques at the beginning of this section: the drone is not an organoleptic technique or a simple instrument. However, its purpose is visual.

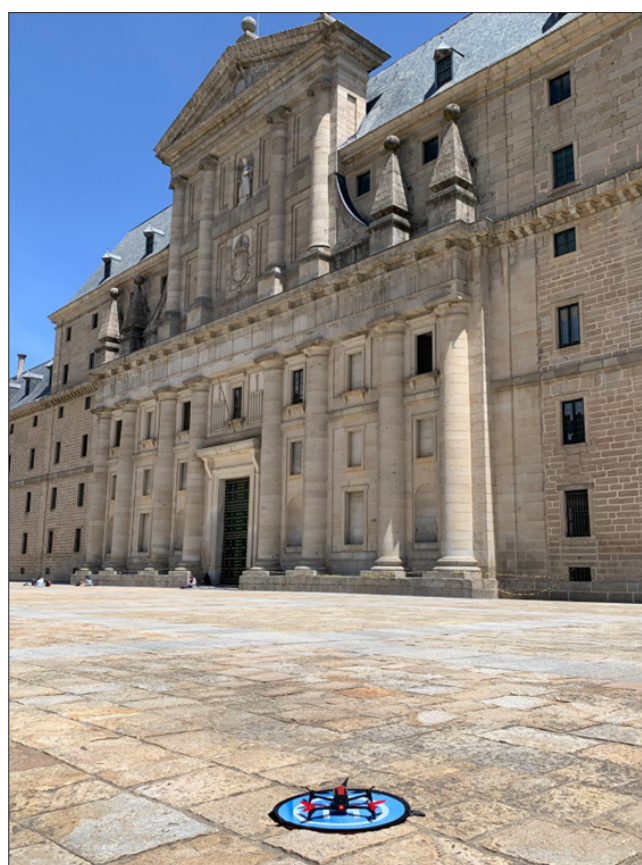
**Figure 2:** Quadrotor drone ready to take off, for an inspection on the main facade of the Monastery of El Escorial, Spain (photo by the author).

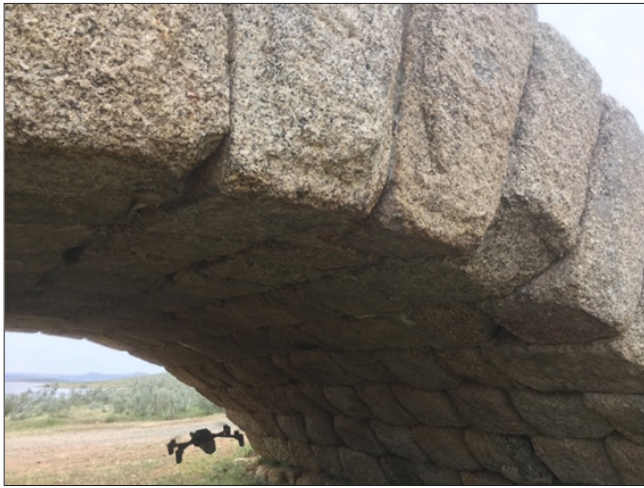
**Figure 3:** Quadcopter drone circulating inside the first vault of the Roman Bridge of Alconetar (Spain), for inspection of its intrados (photo by the author).

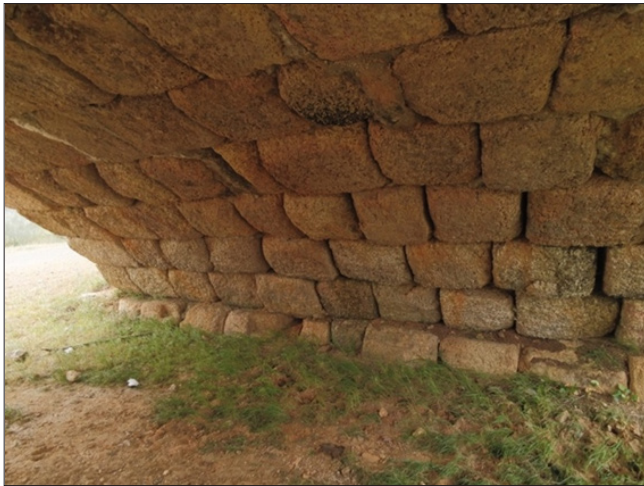
**Figure 4:** Image taken by the drone during its transit through the interior of the vault, captured in Fig. 3 (photo by the author).

All of the above implies considerable economic savings, which does not imply a decrease in the quality of work. With the data collected with the drone (Fig. 4), a complete technical report of the inspection carried out can be generated in the cabinet, in addition to supplying the pertinent information for its incorporation into a management system and obtaining the status indices of each of the elements and the construction as a whole, to assess whether any type of urgent action is required or to verify, through a regular check of the injuries detected through periodic flights, the evolution of said injuries.

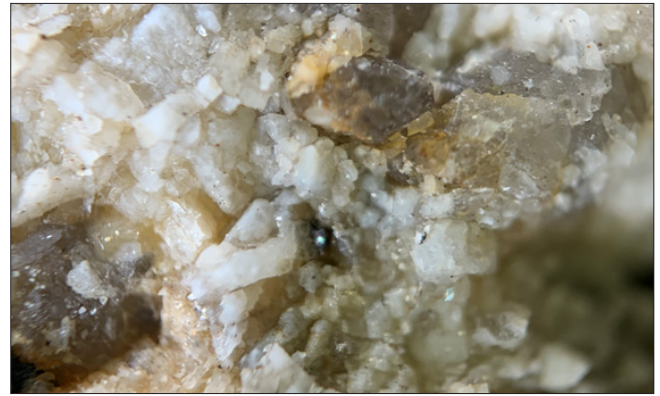
**Figure 5 :** The texture of the granite of an ashlar from the Monastery of El Escorial (Spain), seen with a 50X magnifying glass (photo by the author).

The granites, generally light gray tones, can appear pink and red. Granites are well recognized by the equidimensional granular texture (Fig. 5). The grain size can vary from a millimeter to more than a centimeter. However, the size of normal grains is 2 or 3 millimeters. Its minerals cannot be scratched with a knife.

Granite is the sum of quartz, mica, and feldspar. Thus, calcosodic feldspar is always white and potassium feldspar can also be white or cream-colored (Fig. 5); however, the potassium feldspar in some granites is pink or red. In any case, all feldspars have a stone-like sheen.

Morphologically, mica is laminar and shiny. It can be white or black. (in Fig. 5 it is black). Its strong basal transept is characteristic. Sometimes several small sheets are grouped into one unit. Black mica may have a certain bronze sheen (Fig. 5). For its part, the quartz of the granite appears as grayish grains. Granite can have different particular textures. For example, it can present large white feldspar crystals, like “horse’s teeth”. In some varieties these crystals are sporadic, but in other varieties, they are very abundant. Sometimes they show up oriented. Black micas can also form dark aggregates.

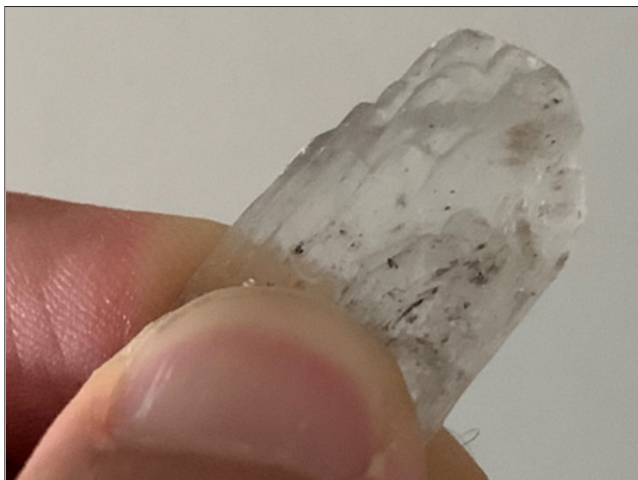
**Figure 6:** Crystallized gypsum, which can be scratched with a fingernail (photo by the author).

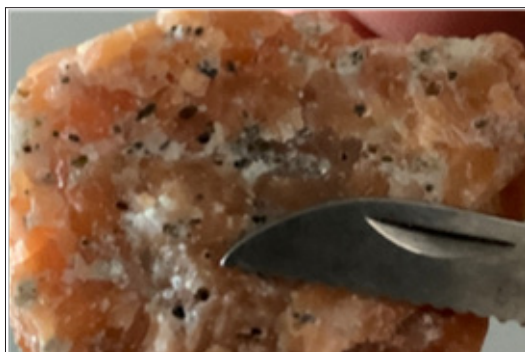
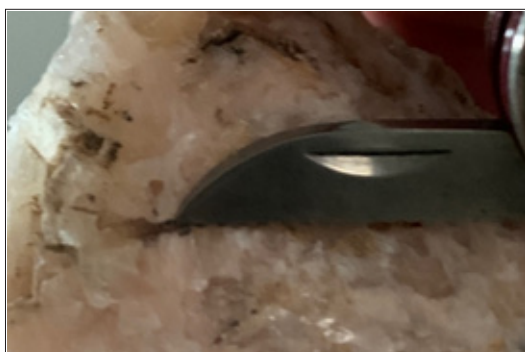
**Figure 7:** Limestone and dolomite are sedimentary rocks that can be scratched with a knife: to differentiate the two, we often need to resort to the use of acids (photo by the author).

The limestones and dolomites are identical. Both are easily scratched by a razor (Fig. 7). Their colors and textures can vary widely. With a drop of hydrochloric acid, limestone produces strong effervescence, while dolomite is not affected. This serves as a diagnosis to distinguish them (Liu et al., 2005).

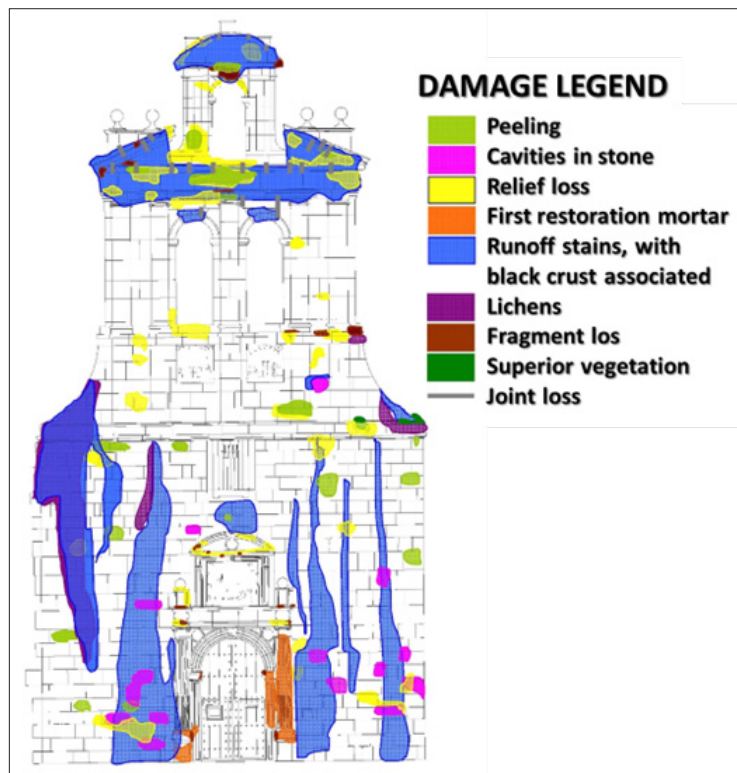
**Figure 8:** Lesions mapping on the main facade of the Chapel of San Ildefonso, in Alcalá de Henares, Spain (Elizalde, 2012).

Many times it is interesting to carry out the mapping of injuries and, in parallel, the mapping of processes (García de Miguel, 2009). The difference is evident: the lesions are immediate and do not admit of interpretation. With this we try to reflect the existing damage, regardless of its cause. The processes require an interpretation. For example, if a plinth affected by capillarity appears, we will see damage to the materials. The cartography of injuries will reflect these damages without clarifying their origin (Fig. 8). However, process mapping will represent the cause, regardless of the nature of the damage.

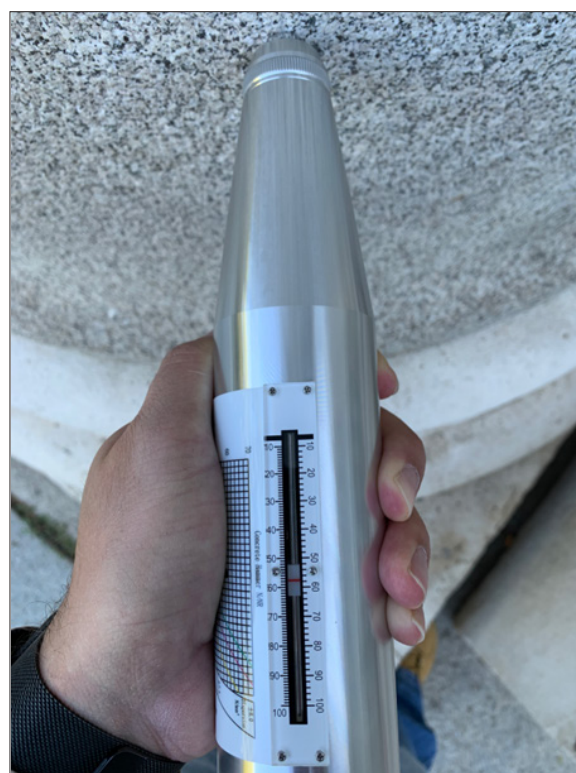
**Figure 9:** Measurement of the mechanical resistance by means of the Schmidt hammer, in a column at the entrance of the Prado Museum in Madrid, Spain (photo by the author).

It is a non-destructive method, so the instrument cost is very useful in heritage where, due to the historical-artistic value of the material, it is often not possible to extract specimens to carry out laboratory tests (Fig. 9).

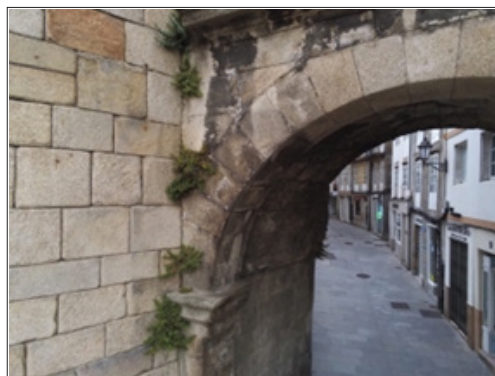
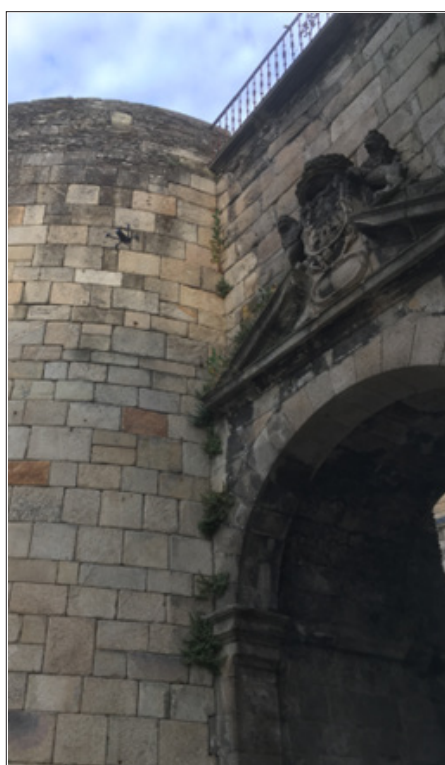
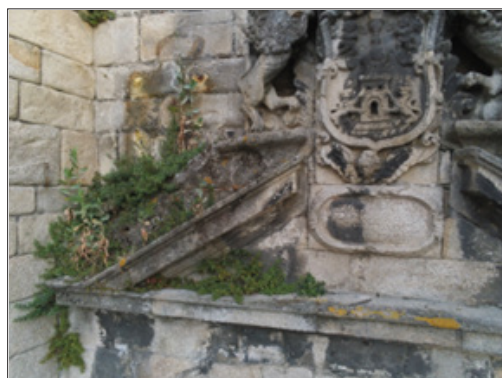
**Figure 10:** Flight of a quadcopter drone during the inspection of a singular point of the Roman Wall of Lugo; specifically in the Porta de San Pedro ou Toledana and images captured by the drone, where the deterioration of the stone material can be observed (photographs by the author).

Orientation can also play a role in the typology of injuries (Camuffo, 1986; García de Miguel, 2009). Here the Porta de San Pedro ou Toledana of the Roman Wall of Lugo has been given as an example. Undrone during an inspection, a drone (Fig. 10) showed that in its east orientation (outer side of the wall), it received contamination from outside. Because of this, black scabs appeared. Loss of relief and sandstone, in synergy with biological growth (Fig. 10). Vehicles cannot circulate inside the wall (only in exceptional cases) for years. For this reason, the granite appeared clean on the west face (interior side of the wall).

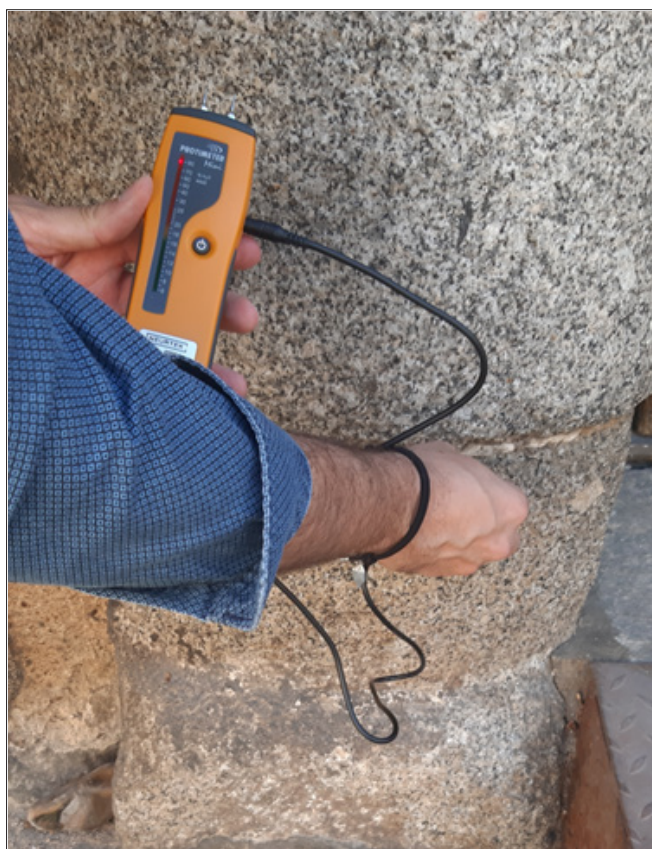
**Figure 11:** Humidity measurement using a protimeter in the columns of the access gate to the Palace of King Don Pedro

Humidity mapping is carried out with a protimeter (Fig. 11). A protimeter is essentially a moisture measurement probe on surfaces. It makes point estimates of the electrical conductivity of the material. Distilled water hardly conducts electricity. However, in construction, moisture carries electrolytes due to dissolved salts. These electrolytes make this water quite conductive.

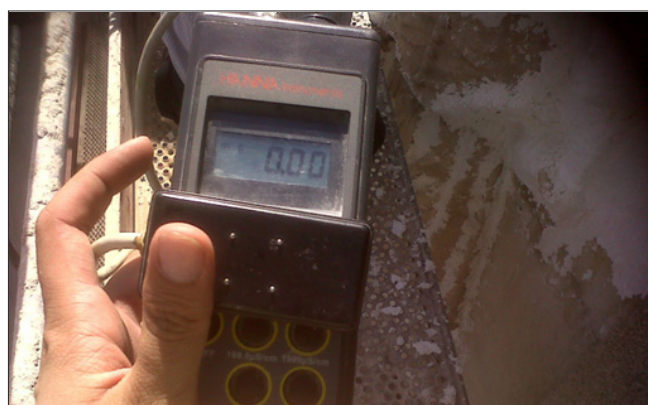
**Figure 12:** Equipment used for the measurement of conductivity and, therefore, for the measurement of salts in the Patio de Santo Tomás of the University of Alcalá de Henares, in Spain (photo by author).

To carry out the mapping of salts, previously there was equipment on the market for the measurement of salts. However, some of this equipment has been discontinued, so it is less accessible. It forced many professionals to look for alternative solutions. Thus, Professor José María García de Miguel designed and built a piece of equipment based on electrical conductivity also (García de Miguel, 2009). In this equipment (Fig. 12) we do the measurement in a different

way: we use filter paper, moistened with distilled water on the surface where we want to measure the saline content. Thus, the paper transmits moisture to the material. After a few seconds, the salts that lodge in the pores of the material dissolve in the moisture that impregnates the paper. So, we place the paper between some electrodes and measure the conductivity. This measured conductivity will be proportional to the saline content in the water dissolved in the paper and, ultimately, to the salts that have been extracted from the wall.

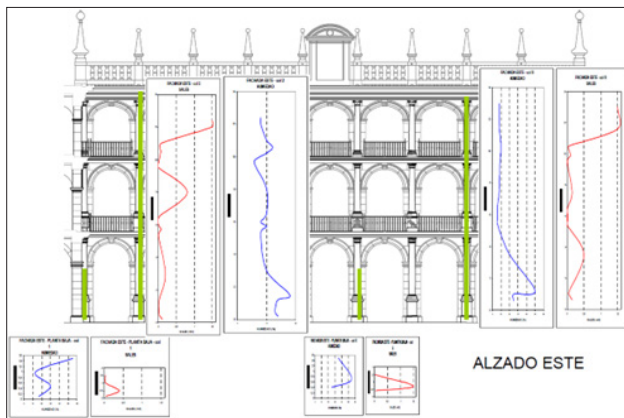
**Figure 13:** Moisture profiles (blue) and salt concentration profiles (red) in the plane of the east side facade in the Patio de Santo Tomás, at University of Alcalá de Henares, Spain (Elizalde, 2012).

The determination of the humidity at each point is quite fast. Thus, we can take many points in a short time. These points can be established according to a regular grid, but it can be difficult in situ, due to access difficulties. (Fig. 14). When the element is linear, such as a column, profiles can be made (Fig. 13, color blue).

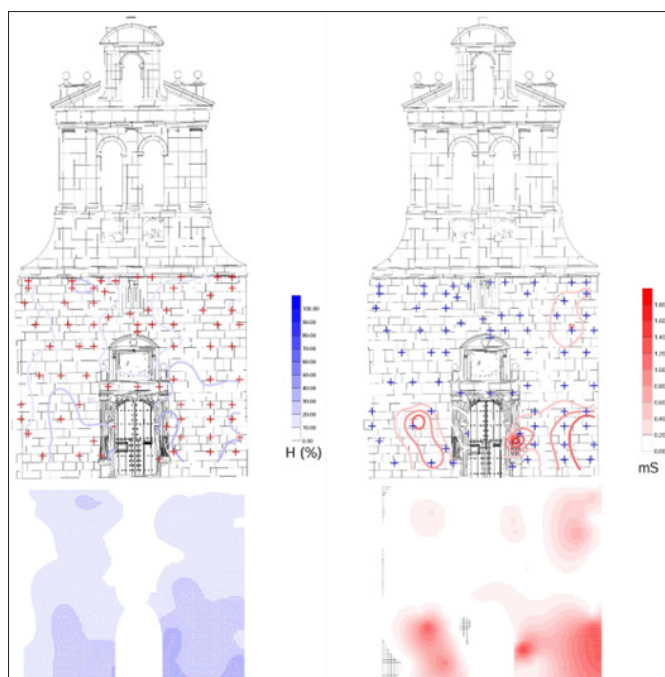
**Figure 14:** Humidity cartography and salt concentration cartography in the elevation of the main facade of the Chapel of San Ildefonso, in Alcalá de Henares, Spain (Elizalde, 2012).

The maps of salts and humidity can be superimposed. This superposition provides us with information about the presence of fossil salt fronts or active salt fronts. An occasional event such as, for example, the breakage of a sewage pipe, can be the cause of salts remaining after solving the cause that contributed the humidity, generating a fossil front.

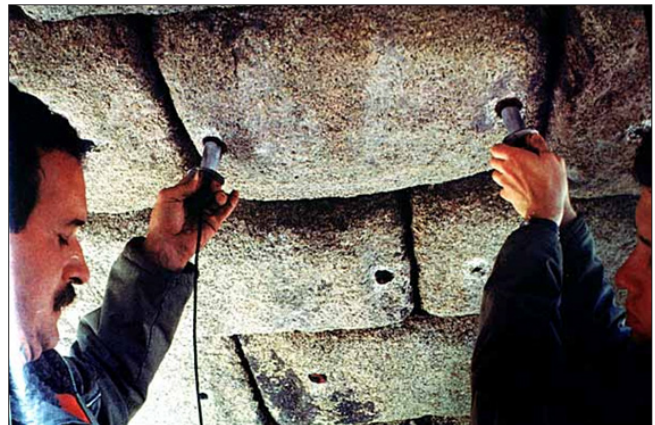
**Figure 15:** Auscultation of the ultrasonic transmission speed in the ashlars of the Roman Aqueeduct of Segovia (Jurado, 2002)

The estimation can be done by reflection, but it is usually done by transmission. The best situation occurs when you have two facing surfaces, such as a wall accessible from both sides. When estimation is not possible in this way, it is possible to place the emitter and receiver on the same surface (Fig. 15).

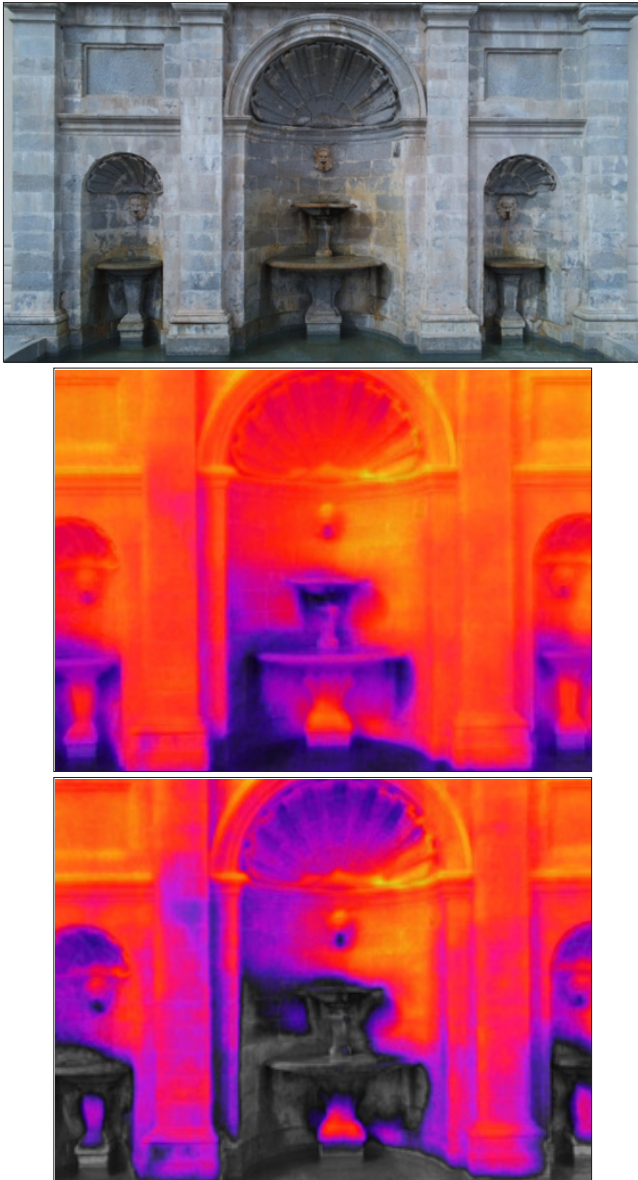
**Figure 16:** Thermographic analysis of the Ventura Rodríguez Fountain, an ornamental fountain from the 18th century, in Boadilla del Monte, in Spain (photo by author).

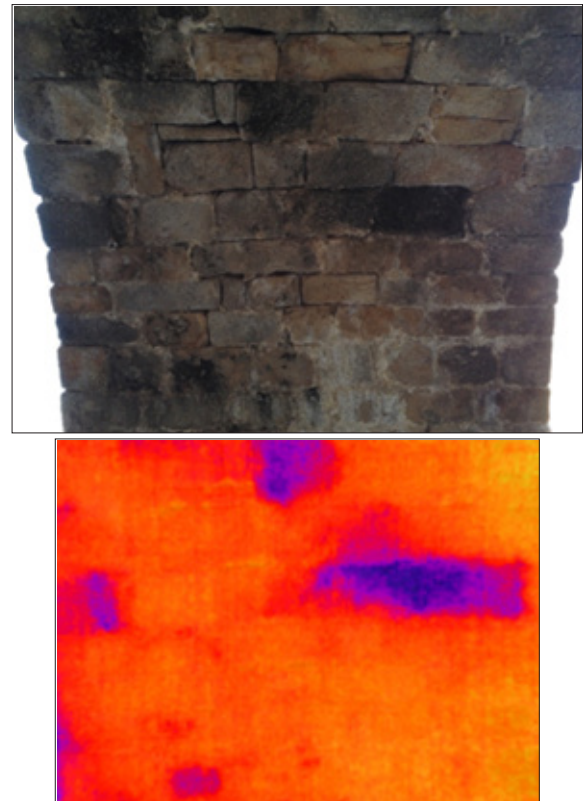
**Figure 17:** Comparison between the real image and the image captured by the thermographic camera, inside the vault of the Puente del Grajal (photographs by the author).

Next, we can see the thermographic analysis of the interior of a masonry arch bridge (Fig. 17) and of the gable end of the bridge abutment with the range of temperatures (Fig. 18). Both images correspond to the Grajal Bridge, inspected by the author (Elizalde, 2022).

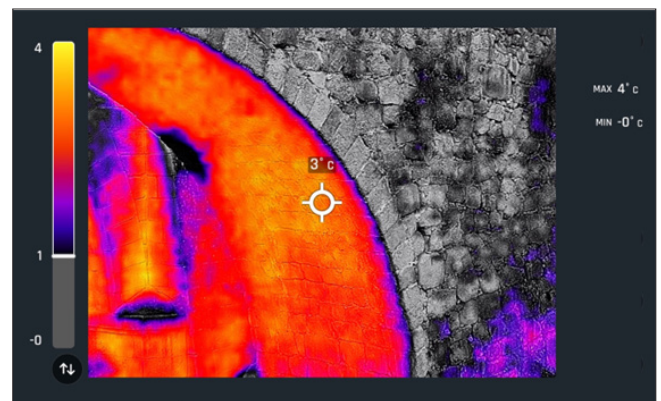
**Figure 18:** Thermographic analysis of the Grajal Bridge, in Spain, with relative scale of temperatures recorded during the inspection (photo by author).
