The Asphalt Rutting Within a Highway Tunnel A Case Study

Asphalt rutting is a major permanent degradation issue caused by the high temperature and the cyclic load of vehicles along roadways. In this work, a highway slow lane within a tunnel was affected by a relevant deformation in a relatively short time. The investigation focused on a 200 m road distance. Benkelman deflection tests on the road surface, measurements of the depth of the road deformation, particle-size distribution of the road base, Proctor and CBR tests were performed. The unbinder underground material matched the required limits. Moreover, a concrete basement with a thickness up to 60 cm was present between the upper bituminous layers and the unbinder sub-base. The concrete increased the stiffness of the whole pavement system. The road base exhibited a good bearing capacity, while the reason for the rutting needed to be found in the middle and lower bituminous layers, in spite of the wide curvature of the permanent deformation.

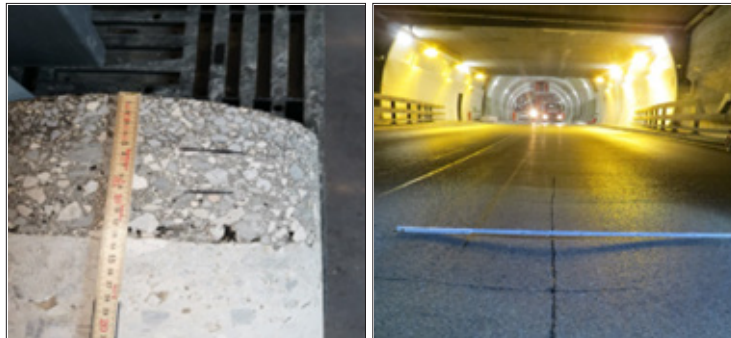
A visual inspection of the pavements indicated a clear rutting of the surface (Fig. 1 right).

The stratigraphy of the pavement consisted of an asphalt concrete AC 16 H PmB modified with polymers that restored an existing stone matrix asphalt SMA 11 with rutting. The SMA 11 surface course exhibited a compaction degree, macropores content and granulometric curves that respected the required limits. The binder as well as the base layer types were unknown. The bituminous top layer exhibited a thickness of 45-55 mm, the middle layer 40-45 mm and the base layer 40-45 mm. The layers can be partially identified with the color difference, with some partial detachments at the interfaces. Underneath the bituminous layers, an unreinforced concrete basement was present (Fig.1 left). Below the cement-based material an unbound granulate layer was used to level the rock basement. In fact, rock were partially present along the high-low speed lanes. The changes in the underground characteristics may emphasize the damage and lead to fracture along the depression. Unbound granulates were partially observed underneath the rutting.

Figure 1: (Left) Pavement stratigraphy. (Right) Rutting along the highway lane.

The restoration of the situation was done by milling the bituminous layer down to 130 mm and by placing an asphalt concrete with a macro roughness AC MR 11 (40 mm) with a polymer modified bitumen PmB 45/80-65 E fibre reinforced (Aramid monofilament dosage 500 g/t asphalt by mass). A stress absorption membrane interlayer SAMI with water sealant purpose with a thickness of 10 mm and a high modulus of elasticity asphalt concrete AC 22 EME C1 (80 mm) with a bitumen B 15 / 25 fibre reinforced, that means a more rigid asphalt concrete layers was also placed.

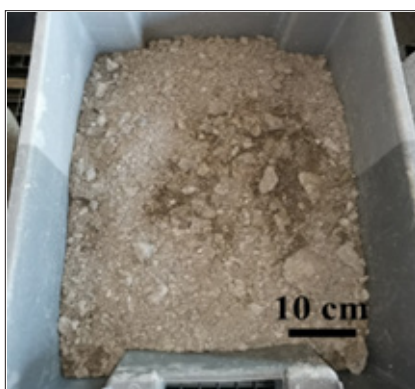
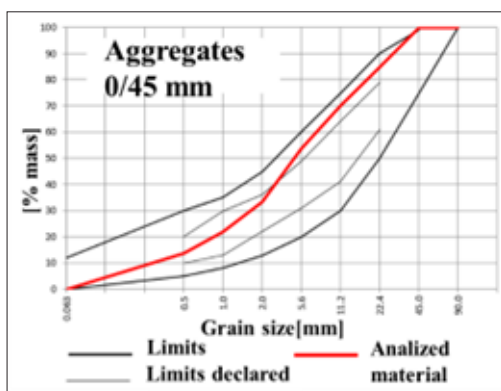
The particle size distribution analysis of the unbound layer underneath the concrete taken at a depth of 80 cm (Fig. 2 top) exhibited a slight lack of coarse grains (Fig. 2 bottom). This fact may be due to the rolling breaking of the aggregate components during the service life. The fine components fitted a little better the required limits. The fraction (0.063 mm) exhibited 4.8 %, while the limit was set at 12%.

Figure 2: Analyzed unbound material (top) and particle size distribution (bottom).

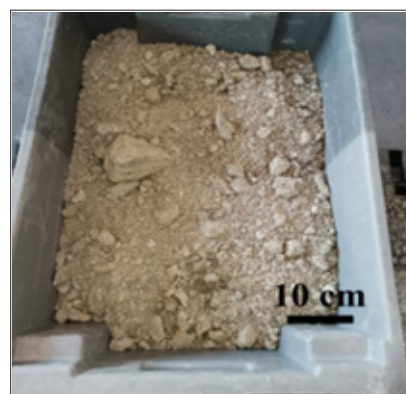
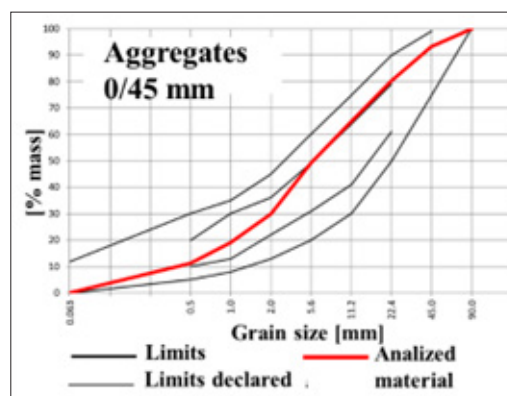
Additional analysis fitted a little better the required limits. In this case, the fine component (0.063 mm) indicated 3.4 % and the required limit remained 12 % (Fig. 3).

Figure 3: Analyzed unbound material (top) and particle size distribution (bottom).
