The Influence of Intermittent Localized Corrosion on the Mechanical Properties of Steel Rebars

Christian Paglia

Institute of Materials and Construction, University of Applied Sciences of Southern Switzerland, DACD, V. F. Ruchat 15, 6850 Mendrisio, Switzerland.

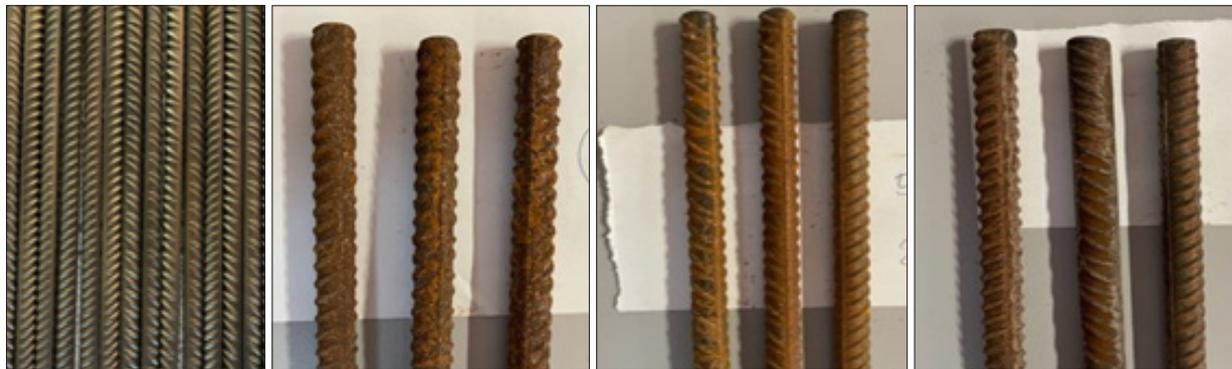
degree of corrosion. The reference specimens do not exhibit a visual presence of uniform corrosion or pits (Fig. 1 left). The steel rebars exposed at 25°C exhibit a rust grade D, namely the highest presence of corrosion features (Fig. 1 centre-left). By increasing the temperature, the rust grade shifts from the level C, for the specimens heated at 50°C (Fig. 1 centre-right), to the level B for the specimens exposed to a temperature of 100°C (Fig. 1 right).

Figure 1: Steel rebars exposed to a 3.5% wt. NaCl solution and after the exposition to an increasing temperature (from left to right).

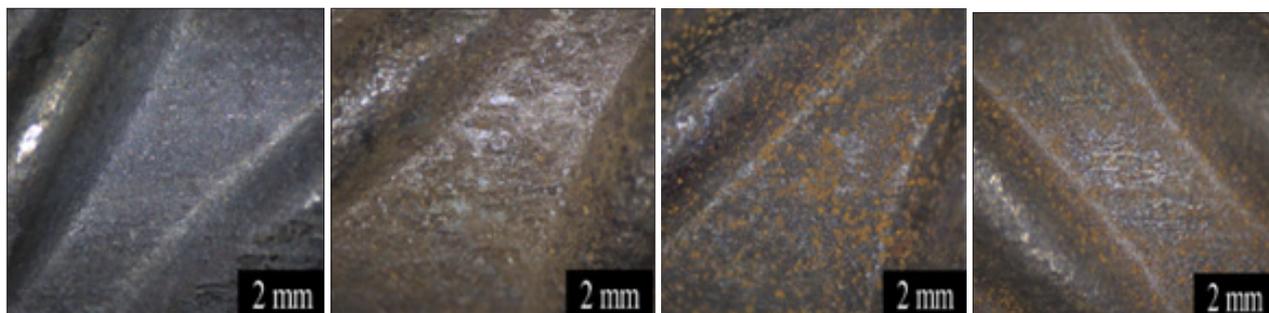
A more detail investigation of the corrosion features along the steel rebar surface indicates the reference samples with a relatively clean surface (Fig. 2 left). Contrarily, the samples exposed at 25°C exhibit a more advanced corrosion stage (Fig. 2 centre-left), although a more intense localized form is seen for the samples exposed at 50°C (Fig. 2 centre-right), followed by the 100°C exposed samples. In this latter case, the water evaporation is faster and the corrosion intensity is slightly reduced (Fig. 2 right).

Figure 2: Binocular lens images of the corrosion morphology along the steel rebars: reference, rebar at 25°C, rebar at 50°C, rebar at 100°C (from left to right).

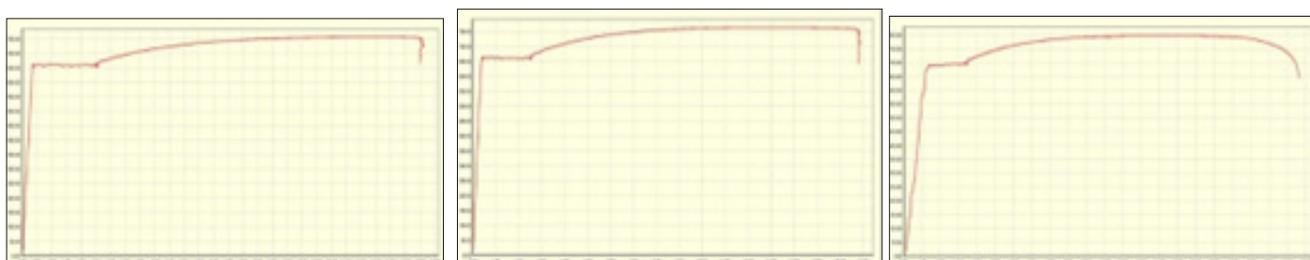
The stress-strain curves shape of the reference specimens exhibits a yield plateau and a yield strength $R_{p0.2} / R_e$ of 670 ± 16 MPa. The maximum tensile strength reaches 772 ± 23 MPa and the strain A_{gt} shows a mean value of $12 \pm 1.5\%$ (Fig. 3). A slight strain hardening and necking in the final phase of the curves are observed.

Figure 3: Stress (y-axis)-strain (x-axis) curves shape of the reference steel rebars.

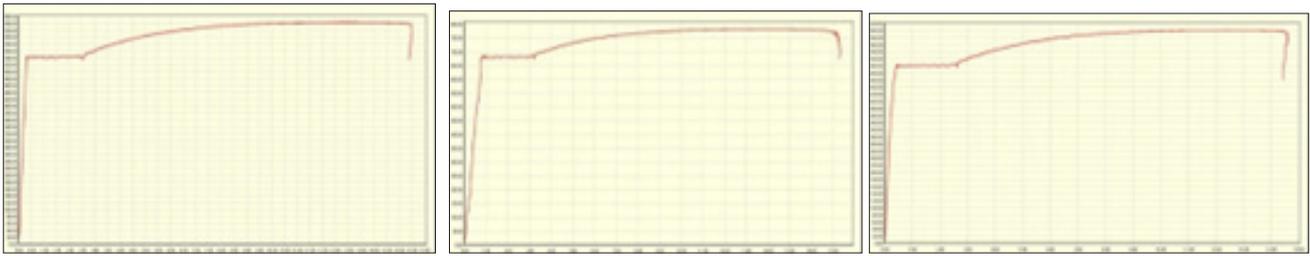
The graphs of the steel rebar specimens continuously exposed to the 3.5 weight % NaCl and showing the highest rust grade D, indicate a rusted steel surface and with a general pitting and a clear yield plateau (Fig. 4). This in spite of the relatively advanced corrosion stage (Chena et al., 2020). The yield strength $R_{p0.2} / R_e$ exhibits a mean value of 573 ± 94 MPa. The maximum tensile

strength shows a value of 674 ± 94 Mpa and the strain A_{gt} shows $13 \pm 0.7\%$.

Figure 4: Stress (y-axis)-strain (x-axis) curves shape of the steel rebars continuously immersed in a 3.5 % NaCl at 25oC.

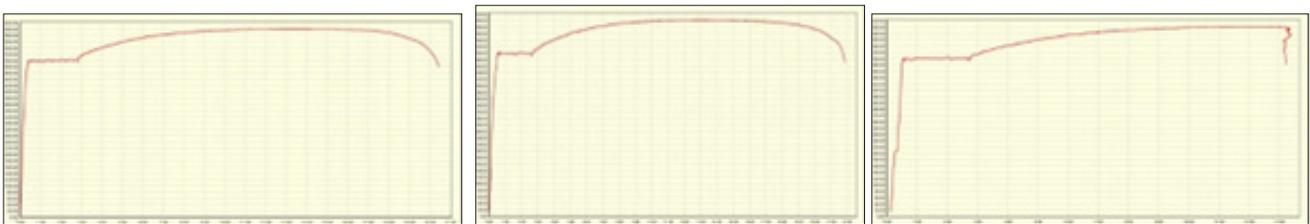
An increase in the temperature at 50oC for the specimens intermittently sprayed (every six weeks) with a constant amount of 3.5% NaCl solution and after two minutes placed in an oven at 50oC, with the procedure repeated for 10 months, maintains a characteristic shape of the stress-strain curves, with the mean yield strength $R_{p0.2} / R_e$ at 496 ± 2.5 MPa, the maximum tensile strength at 600 ± 0.5 MPa and the strain A_{gt} at 12.6 ± 0.4 % (Fig. 5).

Figure 5: Stress (y-axis)-strain (x-axis) curves shape of the steel rebars intermittently sprayed with a constant amount of 3.5% NaCl solution and after two minutes placed in an oven at 50°C.

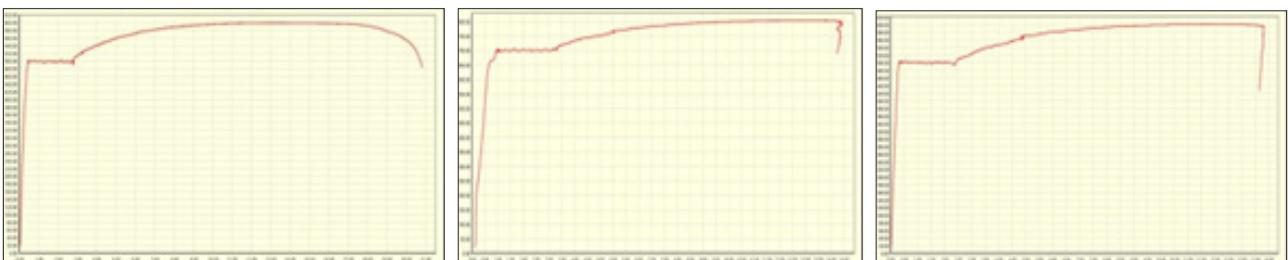
The cyclic exposition to the 3.5% weight NaCl solution and the placing for two minutes at 100oC indicates a similar stress-strain curve shape with a yield strength $R_{p0.2} / R_e$ of 555 ± 96 MPa, the maximum tensile strength at 668 ± 117 MPa and the strain A_{gt} at $13 \pm 0.4\%$ (Fig. 6).

Figure 6: Stress (y-axis)-strain (x-axis) curves shape of the steel rebars intermittently sprayed with a constant amount of 3.5% NaCl solution and after two minutes placed in an oven at 100°C.

The curve shape of the samples exposed to different temperatures in the 3.5% weight NaCl solution shows a similar trend with the elastic region, the yield point, a plateau, a strain hardening region, the necking zone and the failure point.

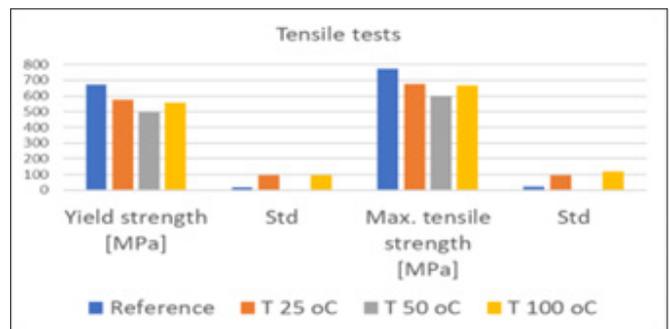
However, as compared to the reference uncorroded samples, the corroded samples exhibit a lowering of the mechanical properties (Sanchez et al., 2017). The lowest values are seen for the 50oC exposed samples, that show a more intense localized corrosion phenomena. The 100oC exposed samples show less intense localized corrosion pits and may have a slight mechanical recovery, due to the temperature. The corrosion of the 25oC exposed samples is more homogeneously distributed, because of the lack of a significant water evaporation and chloride enrichments (Fig. 7).

Figure 7: Mean yield strength and maximum tensile strength of the specimens treated with intermittent chloride and temperature exposure.

At 25°C, the corrosion of the samples immersed in the NaCl solution is clearly visible and a reduction of 15% of the yield strength and 13% of the maximum tensile strength are clearly observed. A similar behaviour of the mechanical properties is seen for the 100°C samples, while the 50°C exposed specimens exhibit an additional slight reduction of the mechanical properties, likely due to the more localized corrosion morphology and intense pitting formation. This temperature may accelerate the kinetics of the localized corrosion. However, the temperature is still not enough to cause a too rapid evaporation of the water as for the 100°C exposed samples. In this latter case, the pit formation is partially inhibited. The rust degree B, C and D decrease the mechanical properties and show a maximum variation of 90 Mpa of the tensile strength. Nevertheless, no direct correlation exists between the rust grade seen on the surface and the reduction of the properties (Zhang et al., 2012; Apostolopoulos et al., 2013; Zhu et al., 2017; Subramanian et al., 2018), as far as the corrosion stage remains in a low to medium level with a few craters and no relevant cross-sectional reduction is measured. This is due to the variable intensity of the localized aggressive spots. In addition, the temperature may largely regulate the corrosion process, speed and form. The pits agglomeration at 25°C emphasizes the advanced corrosion stage and the surface visual appearance of the samples as compared to the 50°C and 100°C samples. With a temperature of 50°C, the localized corrosion is accelerated, while for the 100°C exposed specimens, the rapid humidity decrease, due to higher temperature, lowers the intensity of the localized corrosion.

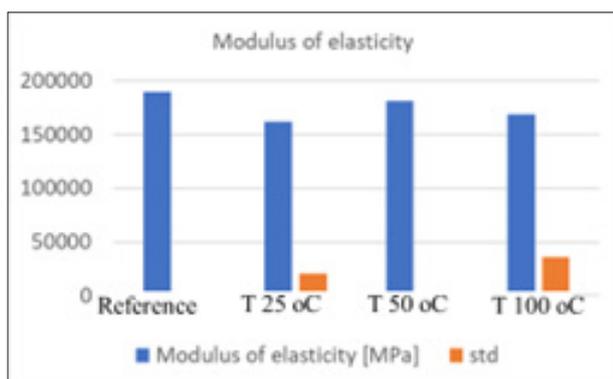
The modulus of elasticity is slightly related to the corrosion advancement stage and type. A more uniform distribution of corrosion pits with the 25°C treatment seems to reduce the values to a lower level as compared to the more localized pits presence of the 50°C exposition or for the specimens exposed to 100°C (Fig. 8).

Figure 8: Modulus of elasticity of the steel rebars after the different exposure conditions and temperature. The standard deviations are not visible in the graph, when they are too small.

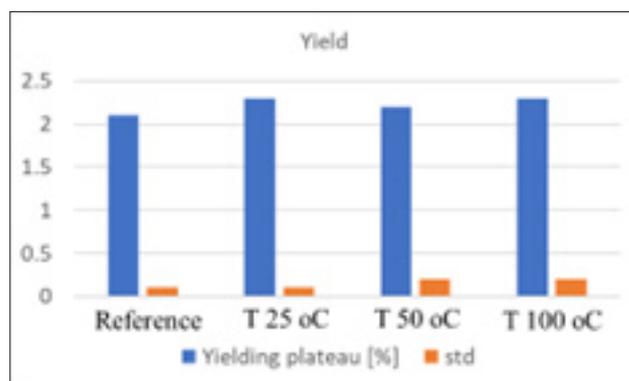
A slightly longer yielding plateau is seen for the corroded samples, especially for the 100°C treated specimens. However,

this behaviour is likely not influenced by the temperature exposition at 100°C. Nevertheless, the values do not change significantly for all tested samples (Fig. 9).

Figure 9: Range [%] of the yielding plateau in the stress-strain graphs of the steel rebars after the different exposure conditions and temperature. The standard deviations are indicated on the side of the columns.

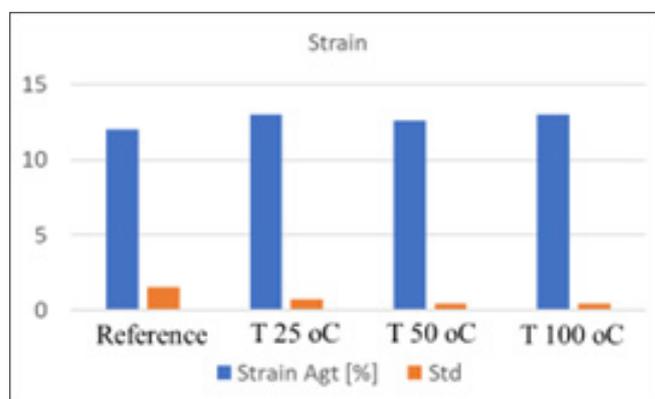
The Agt strains appear not to clearly discriminate the influence of the corrosion on the deformation capability of the rebars. The values are relatively similar at all temperatures. In spite of the higher reduction of the strain as compared to the ultimate tensile strength with an advancement of the corrosion level (Chena et al., 2020), the corrosion stage variation between rust grades (A-D) seems to even slightly increase the ductility (Fig. 10). This is also seen for the highest rust grade D, where the steel rebar surface is completely rusted and general pitting is visible. On the other hand, the corrosion level did not reach yet the formation of relevant craters and cross section loss.

Figure 10: Strain Agt registered on the stress-strain graphs of the steel rebars after the different exposure conditions and temperature. The standard deviations are indicated on the side of the columns.

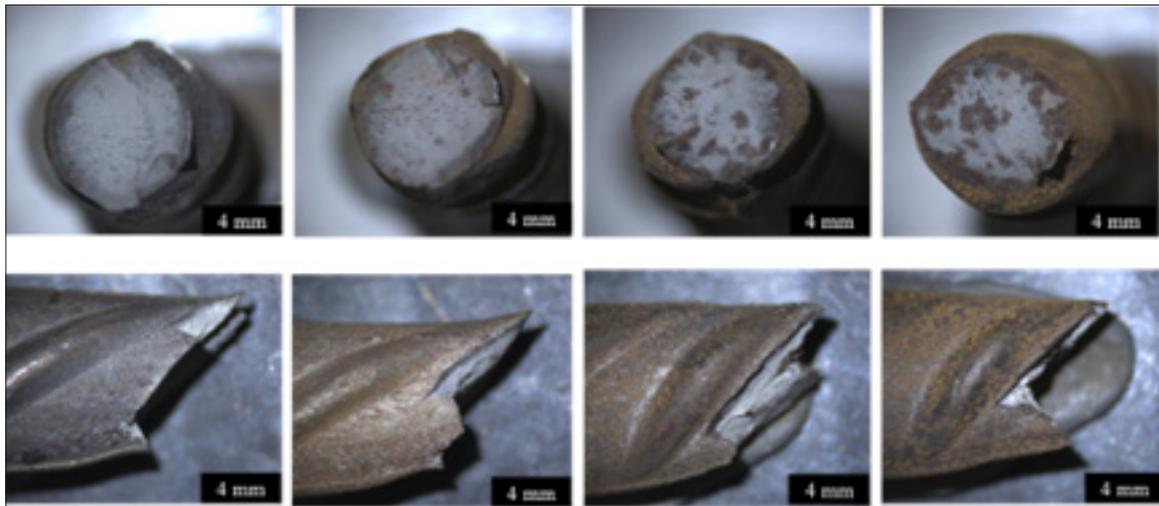
The fracture morphology exhibits a ductile fracture mode of the samples with cup and cone fracture as well as a clear necking in the deformation region (Fig. 11).

Figure 11: Fracture surface of the specimens for the reference, the sample treated at 25°C and constantly immersed in a NaCl 3.5% weight solution, the samples intermittently exposed to a NaCl 3.5% weight solution and treated at 50°C and the samples intermittently exposed to a NaCl 3.5% weight solution and treated at 100°C (from left to right).

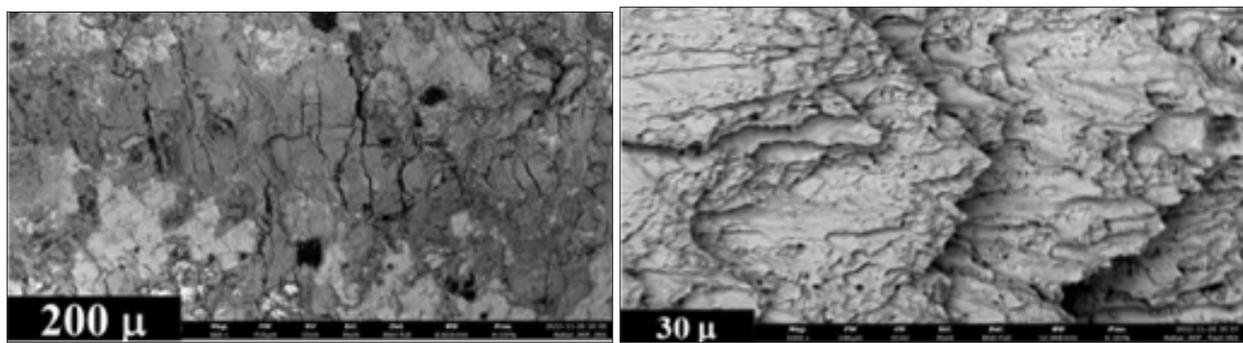
The reference untreated and uncorroded specimens exhibit fine cracks and ductile dimples along the fracture surface (Fig. 12 left-right).

Figure 12: Fracture surface of the untreated reference steel rebars.

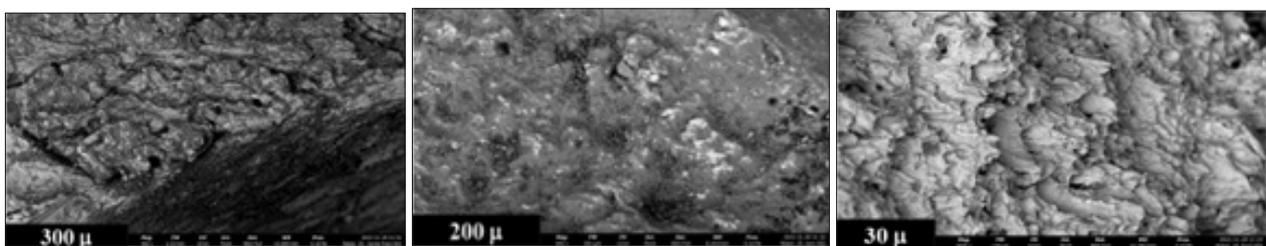
It is difficult to localize the initiation sites along the fracture surface of the steel rebars continuously exposed to the 3.5% weight solution at 25°C. Cracks and microcracks are present on the surface (Fig. 13 left). Surface corrosion products are partially visible (Fig. 13 centre), but the anodic dissolution features are not enough deep to clearly create identifiable corrosion sites for the cracking and the rupture initiation of the specimens. Such tensile tests performed at a relatively high speed rate as compared to environmentally assisted cracking, which are carried out at lower strain rates, are only partially influenced by the corrosion sites. The step-like and shear-tongue features as well as the ductile dimples (Fig. 13 right) indicate the general ductility of the specimens.

Figure 13: Fracture surface of the steel rebars continuously exposed to the 3.5% weight solution at 25°C.

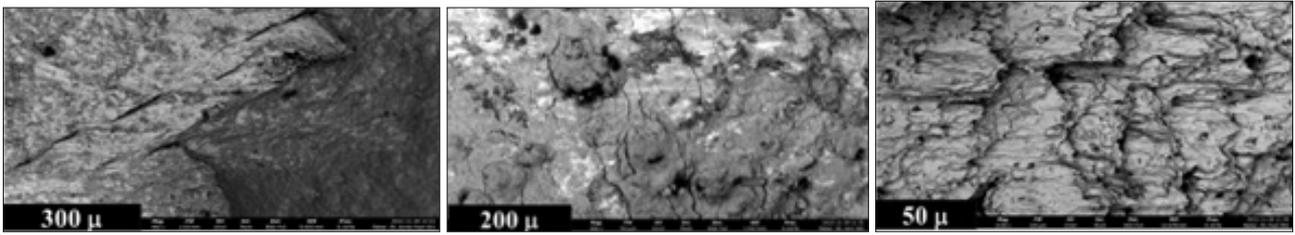
More localized aggressive corrosion pits, due to water intermittent evaporation and sub-parallel cracks perpendicular to the tensile direction and occasionally mud-crack pattern are seen in the specimens treated at 50°C (Fig. 14).

Figure 14: Fracture surface of the steel rebars intermittently sprayed with a constant amount of 3.5% NaCl solution and after two minutes placed in an oven at 50°C. Procedure repeated for 10 months.

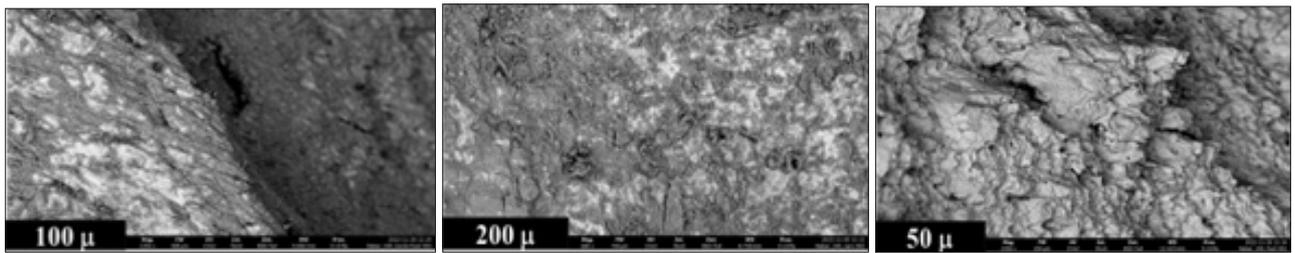
In this case, the corrosion pits tend to create the initiation sites for cracking (Fig. 15 left), although no clear distinct zones are seen, due to high deformation rates. The specimens treated at 100°C exhibit less visible and intense corrosion pits (Fig. 15 centre) and slightly more shear deformation features can be observed along the fracture surface (Fig. 15 right).

Figure 15: Fracture surface of the steel rebars intermittently sprayed with a constant amount of 3.5% NaCl solution and after two minutes placed in an oven at 100°C. Procedure repeated for 10 months.
